## Lower River Otter: Long term options for drainage and flood management

Clinton Devon Estates

Dr. N.E. Haycock

18th December 2009

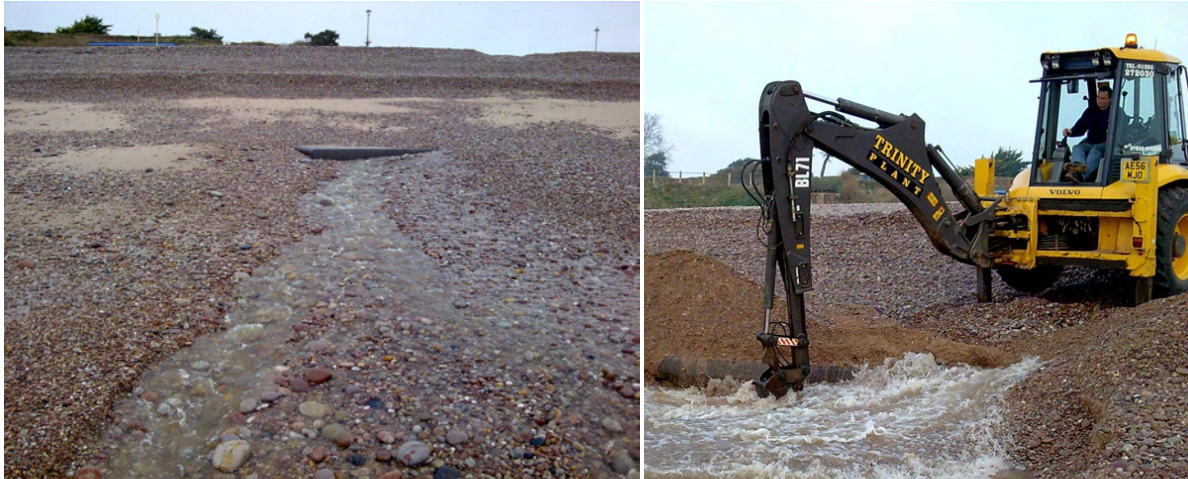
**Figure 12:** Photographs of the embanked compartment outfall on the pebble beach locally to the Lime Kiln, Budleigh Salterton. The left image shows the outflow blocked by gravel and pebbles. The right image shows the Council clearing the outflow which can occur weekly based on BSCC information.

The 975mm outfall at the Lime Kiln has an invert level of -1.6m AOD (Howick and Partners, 2001) and is below Mean Low Water Spring Tide (-1.3m AOD). The Mean tidal is 0.7 mAOD. For the majority of the tidal cycle the outfall is submerged and discharge from the pipe requires a hydrostatic head to build up on the inflow, greater than the tidal level. Once the tide exceeds -1.05m AOD a flap valve starts to become submerged and the discharge efficiency of the embankment drains becomes impaired or ceases. Land levels locally to the Cricket Club are 0.8-1.0m AOD with mean high neap tide approximately 1.50 mAOD. The low elevation of the outflow results in frequent periods when the normal drainage of the embanked compartment is compromised. When the drainage is impaired, excess runoff accumulates within the embanked compartment drains and the low lying fields. If a normal rainfall event (>10mm/day) coincides with impaired drainage over a number of tidal cycles, then key assets will flood. Major incidents of drainage related flooding have been recorded 11 times. But flooding of fields and amenity areas is calculated to be far more frequent based on the elevations of the embanked floodplain land.

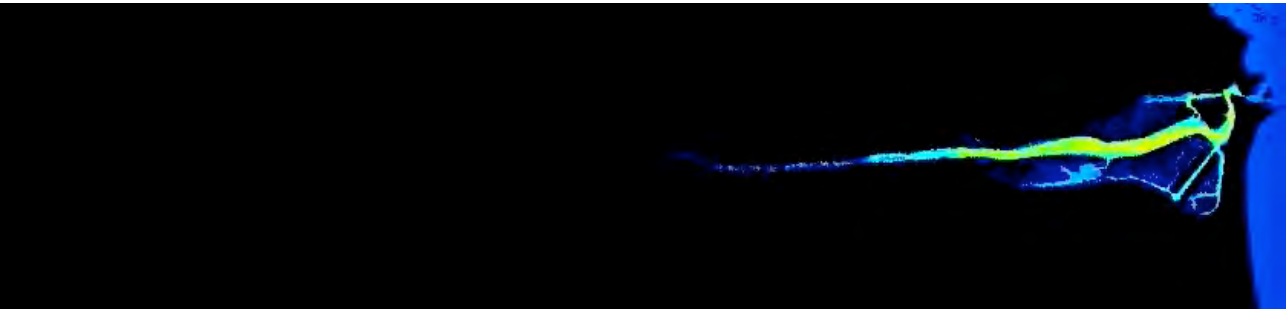
Figure 19: Extent of tidal inundation in mean high neap tide

In figure 18, the extent of the mean low neap tide is presented, which extends up the estuary towards White Bridge and the South Farm Road. At peak height, water floods the lower salt marsh and mud flats in the estuary, but not the upper salt marsh (figure 19). The model therefore agrees with the flood frequency at which the salt marsh habitats naturally occur.

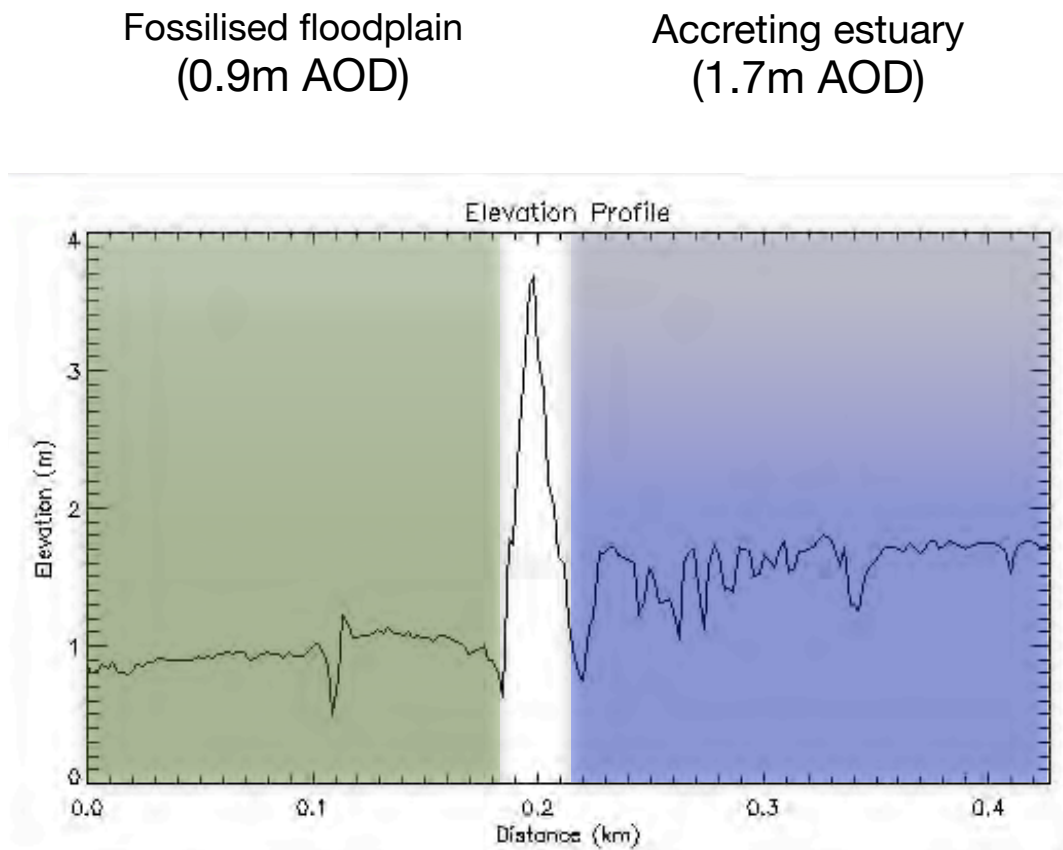
Figure 24: Cross section of land levels from the Cricket Club (0 km on x-axis) through the embankment and into the Otter estuary.

Figure 24 shows a cross section through Big Marsh, locally to the Cricket club. The impact of the accumulated sediments in the estuary will result in the impoundment of 1.0m of salt water on the embanked compartment, resulting in a shallow lagoon or mudflats. It is interesting to note that the sediments in the estuary have accumulated since 1812, therefore equate to 4mm per year of net vertical accumulation.

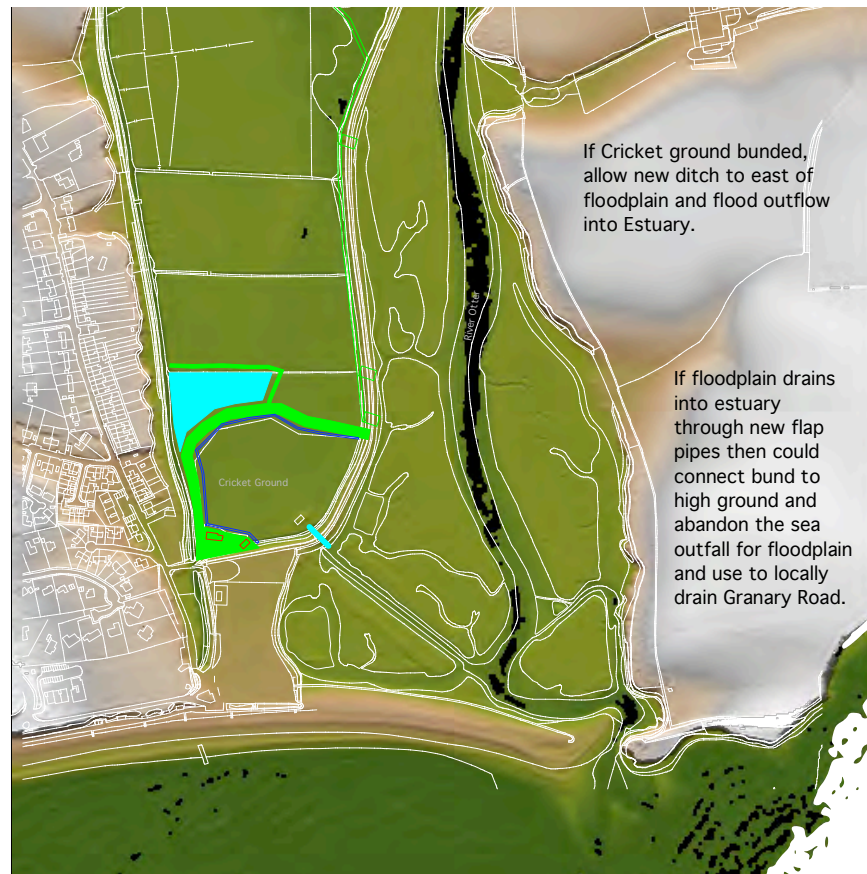
Pumped discharge to estuary by adoption EA pipe and flap valve.

Club house and buildings based on new bund, base level at 3.1m and critical infrastructure at +4.0m due to saline flood risk.

The location of the cricket ground, behind Big Bank, and lying at 0.8-1.0m AOD makes it one of the lowest lying cricket grounds in England. Frequent flooding is making this unique position difficult to sustain. The option for this site, if it is to remain in its historic location, is to bund the ground independently of the main compartment and ensure it is not dependent on the sea outfall at the Lime Kiln, south of the grounds. The drainage of the site would be enhanced, with an inner ring drain, which would be pumped to the Environment Agency sea outfall (marked in light blue in option figure). The current sea outfall would be modified to house a pump and also enable any fluvial flood water and or tidal water that entered the smaller compartment to be gravity drained. With the loss of the EA sea outfall to assist with drainage of Big Marsh, additional outfalls would be required to the north of the ground, to enable the gravity dewatering of Big Marsh into the estuary.

The bund could be created from floodplain material, as was done in 1812, and a borrow pit created north of the grounds. The existing Big Marsh would drain through the Lime Kiln culvert, and the borrow pit would act as a balancing pond to assist with drainage of Big Marsh. The pond would dewater at low tides, assuming that the sea outfall is not blocked.

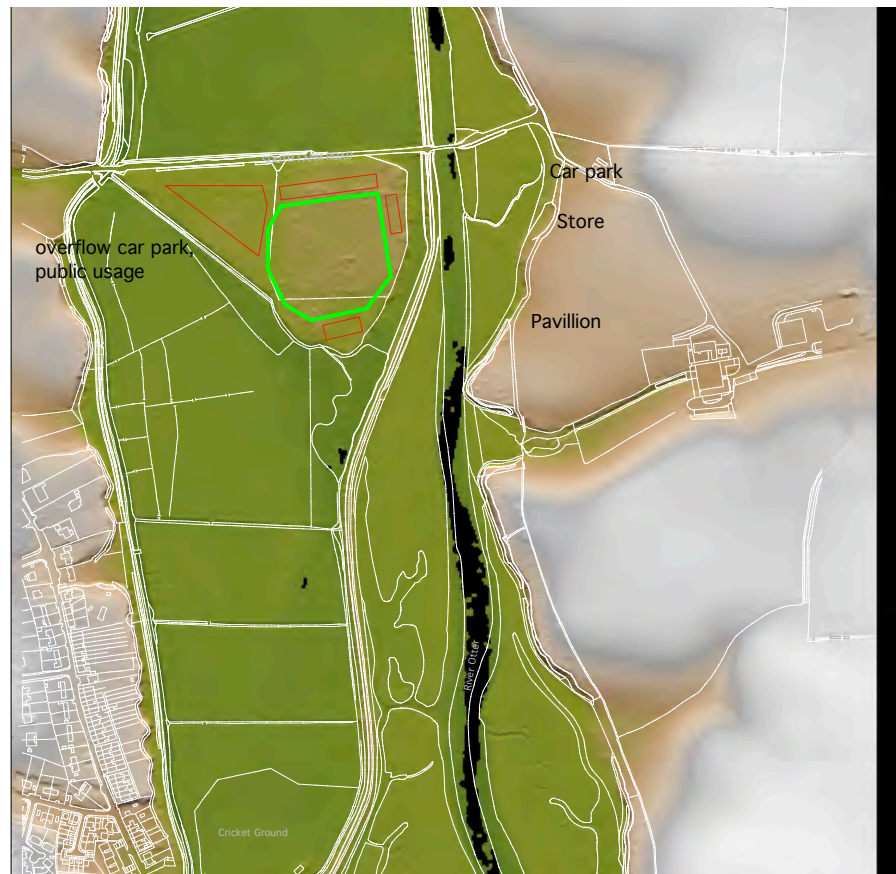
### Option B - Move Cricket Ground

Move cricket ground to former land fill area, raise ground level from 2.8-3.1 to 3.5-3.8m. Spoil created by dredging the Otter floodplain locally to Bridge. Maintain tree perimeter.

In reviewing the operation of the current cricket ground, an option is to change the location of the club, but keep it in the Otter Valley, which is a symbol of the club. In the flood model work, the former refuse site, which closed in 1950, did not flood under a mean annual flood, and in terms of elevation is estimated with be at >1:200 year flood level in relation to tidal limits. The current footprint of the ground fits into the current poplar plantation on the site with room for buildings and car parks to the north and west of the current location. The site would need to be raised to 3.5-3.8m elevation, if not higher, with buildings being placed at 4.4-4.8m invert level. The ground would have an elevated view of the estuary and the southern portion of Big Marsh. The material to fill the site is related in part to option C and D.

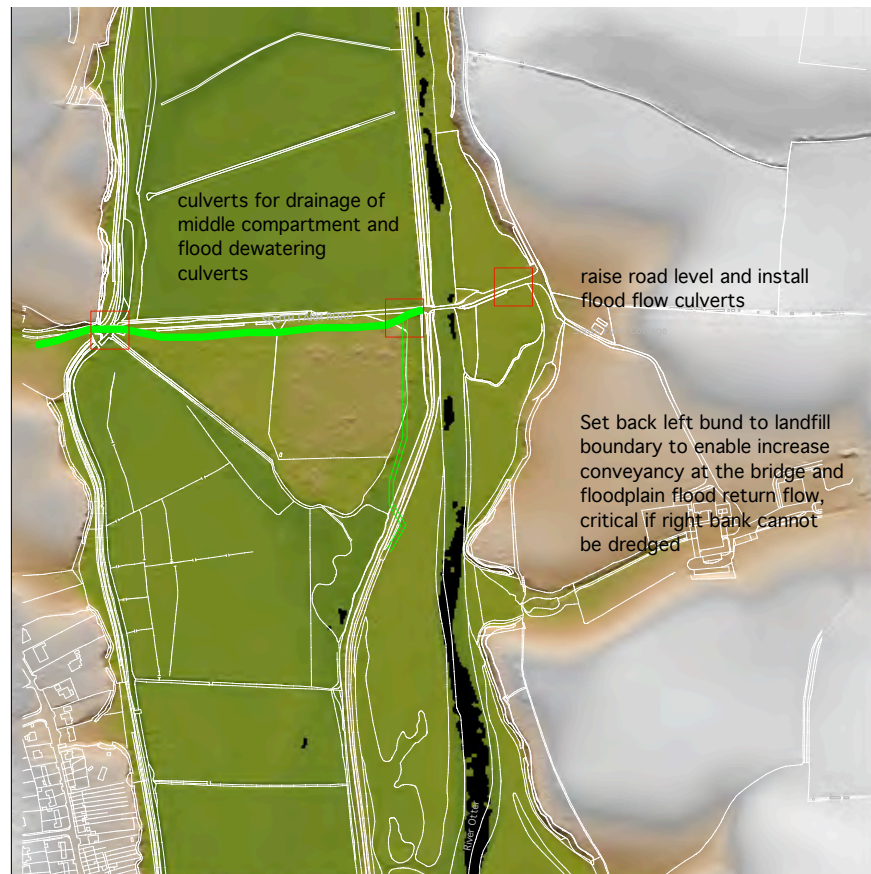
## Option C - South Farm Road

Move road south onto land fill area, make elevation 3.1m, effectively raise level from 1.3m. Red boxes note bridging issues to maintain flow on Otter.

culverts to drain to lower compartment and also flap valves to prevent saline flooding into middle compartment

Independently of option A and B, the issue of ensuring safe passage to South Farm and associated business and buildings, is of key concern to the Estate. An option, is to move the current road south and take advantage of the higher land levels within the refuse grounds.

In the event of fluvial flooding, the conveyance of flood water from the northern section of Big Marsh to the southern section of Big Marsh could be achieved by installing culverts under the road, to the western end of South Farm Road. The material to raise the road could be won from moving the embankment, east of the current refuse site, and aligning westwards. This would increase the hydraulic capacity downstream of the bridge and this section of the estuary.

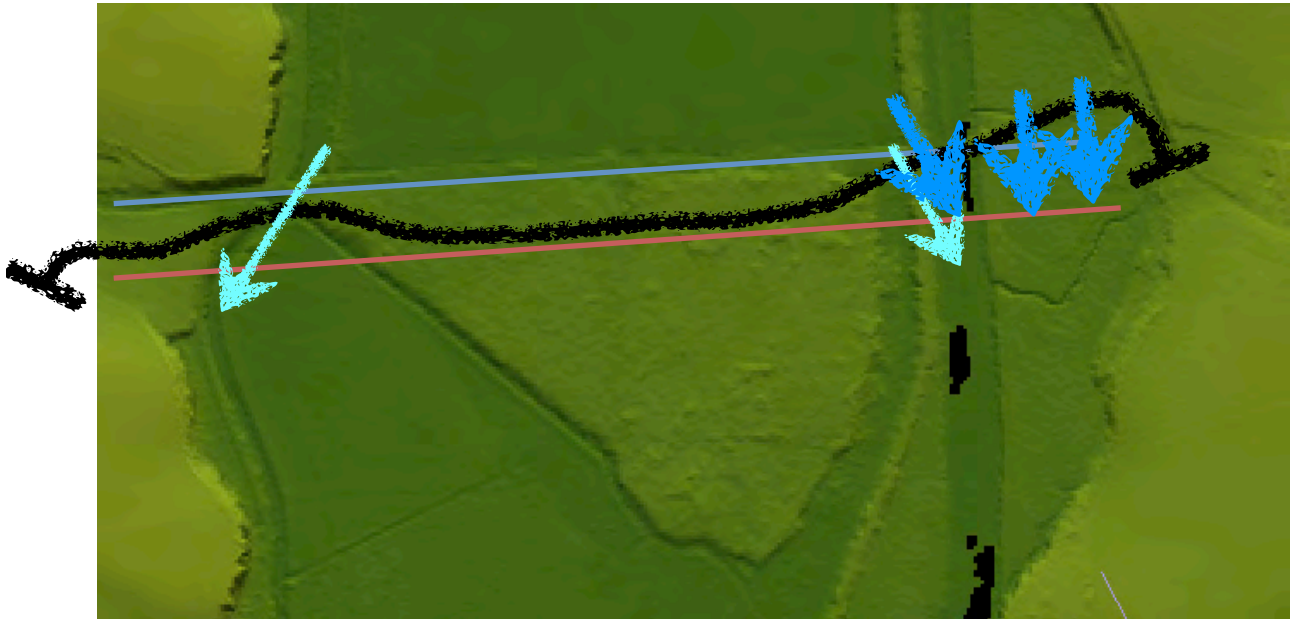
**Figure 27:** Annotated sketch of road route through refuse site and key drainage culverts for drainage of the northern section of big marsh. Option C

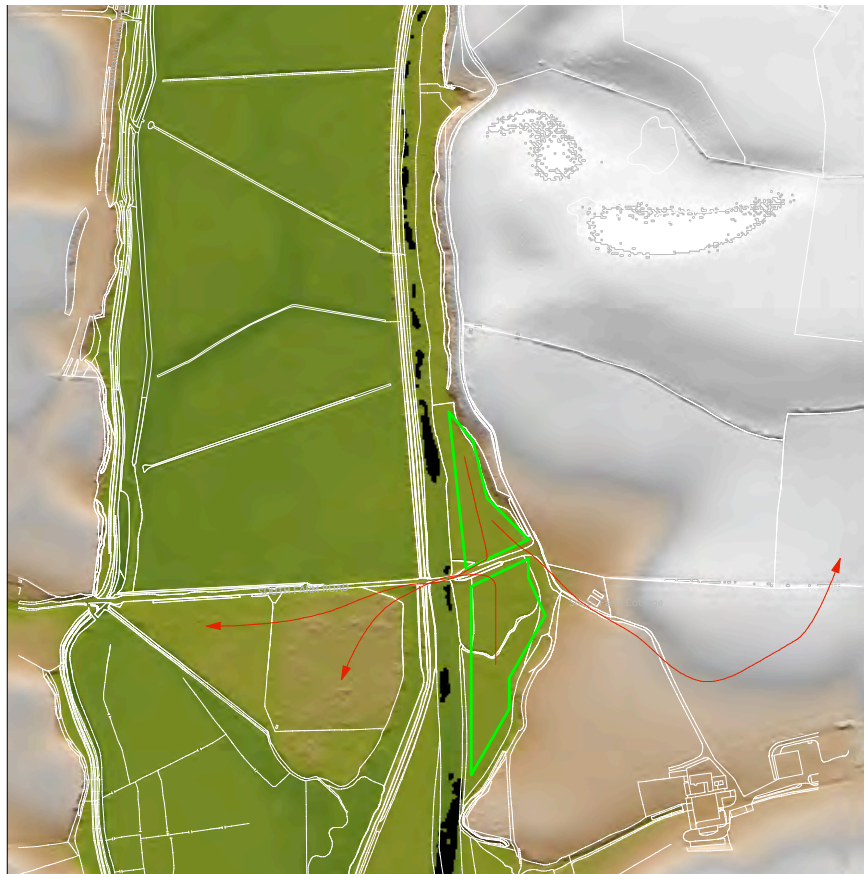
### Option D - Otter floodplain

Lower floodplain to restore conveyance locally to bridge and floodplain flood return flow. No dredging of river and its bed - salmonoid and WFD restrictions. Spoil used to raise tip site for recreation use / car park and road causeway. High quality soil and organic material taken to thin soil locations and incorporated into field soils.

The build up of floodplain land levels locally to South Farm Road bridge is restricting the flow for the upstream section of the channelised River Otter. This section of floodplain should be functional channel to enable the enhanced flow through the Otter upstream. The suggestion is to lower land levels in this section (green boundary), possibly linked to option B and C. The excess material could be moved to the refuse site to raise land levels for the cricket ground (option B) or road levels (option C). Any surplus material could be used to furnish the thinned arable soils on South Farm.

The benefit of this option is linked to enhancements of the overall channel conveyance of the Otter upstream of this location and increasing the volume of flood water through this section, reducing the frequency of flood water entering the floodplain upstream and into Little Marsh.

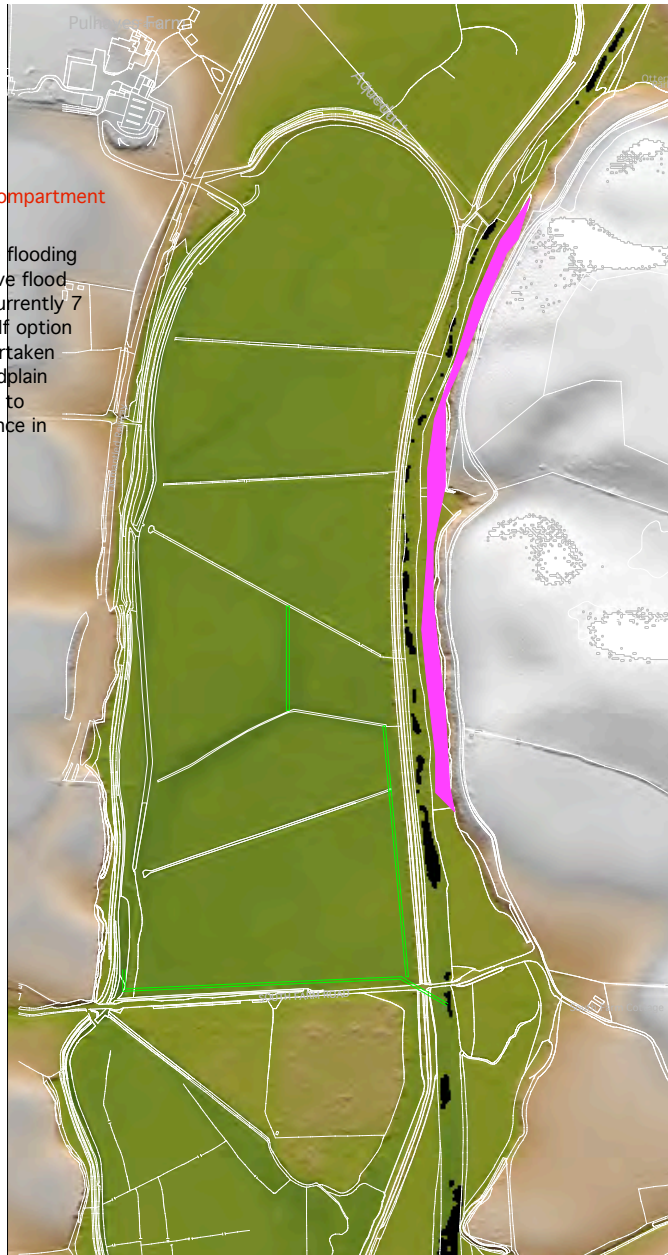
Aim to limit saline flooding (option C). Improve flood water drainage, currently 7 days to dewater. If option G cannot be undertaken then coppice floodplain channel woodland to increase conveyance in this section.

Option F is linked to option E, namely to provide independent drainage of the northern section of Big Marsh if the southern section is to be hydraulically isolated. In option F, the inner drainage of the compartment is to be redirected to outfall into the estuary locally to South Farm Road bridge. This option is also linked to option C, namely raising the lane to avoid disruption as a result of flooding.

The drainage to the south eastern corner would also be associated with an enhance culvert to assist with the dewatering of the site in when inundated with the River Otter flood water. The purple shaded area is linked to option G. The observations of the behaviour of the river in this section are that the accumulated scrub vegetation on the relic floodplain to the east of the river is hydraulically restricting flow and pushing the thalweg of the river to the embankment. This fast flowing water is undercutting sections of the embankment, which has visibly thinned in key sections. The management of this vegetation needs to be reviewed, in combination with option D. If option D and option K (below) are not viable, then thinning and management of the relic floodplain in this section will need to be considered in order to simply maintain the capacity to transfer the mean annual flow (Q2, 70.45 cumecs).

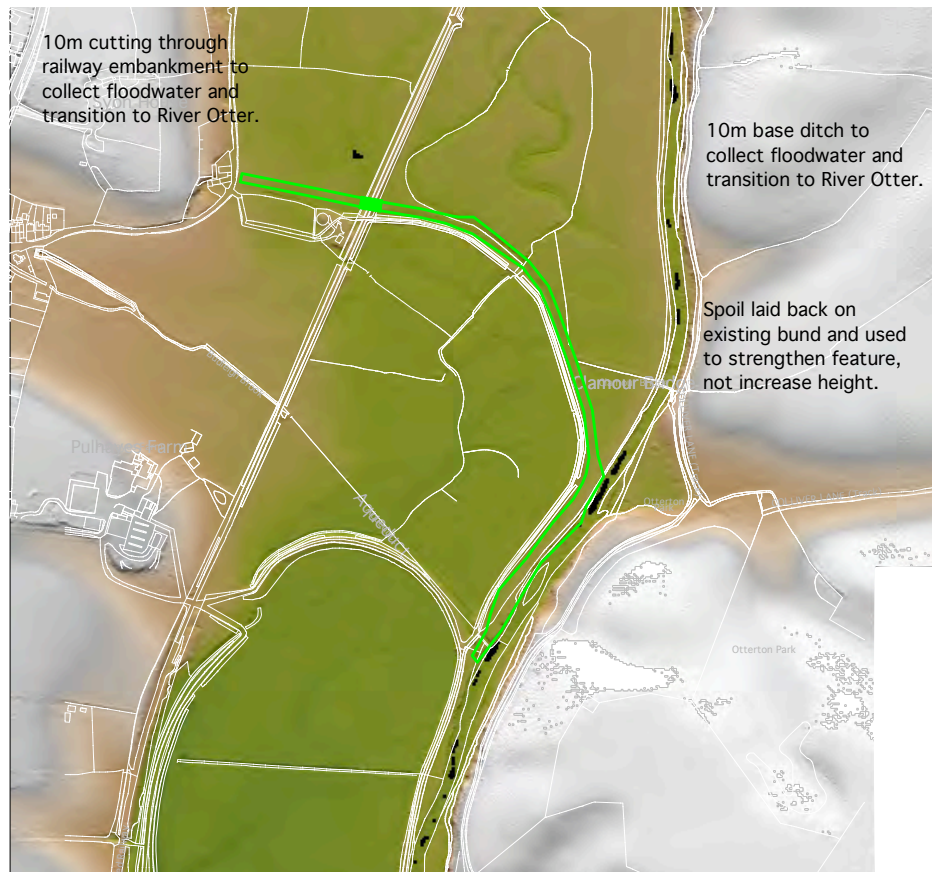
### Option G - Upper Compartment

Aim to direct flood flow back to River Otter and avoid frequent overtopping of bunds. Relic channel connected to river via ditch. Key section of Otter river bank lowered to enable flood flow to transition into leated section.

Option G is linked to option D, namely the functional restoration of channel hydraulics locally to South Farm Road. In this option, the aim is to improve the conveyance of small floods back to the River Otter and avoid the excessive accumulation of flood water ponding locally to Little Bank. The aim is to create a swale upstream of Little Bank, and connect this to the Otter locally to where Budleigh Brook enters the Otter. The land levels where Little Bank runs parallel to the Otter would be lowered to enable water to sweep into the Otter (figure 29). In constructing the swale, with a base width of approximately 10m, the excavated material would be laid back onto Little Bank to strengthen the feature, but not raise the crest levels.

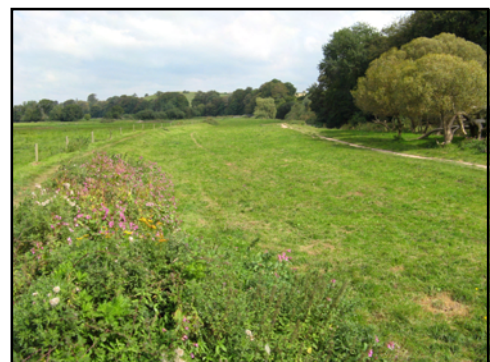
**Figure 29:** Image of Little Bank where it runs parallel to River Otter. This land level is proposed to be lowered in option G.

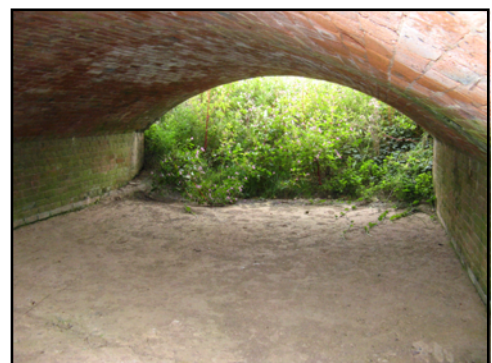
**Figure 30:** Image of the Otterton road culvert to the west of the current bridge and sediment accumulation in the culvert and land levels 1.2m higher on downstream face.

The culverts under the main road need extensive groundwork upstream and downstream in order to lower ground levels to optimise the conveyance of these structures and reduce the build up of water. Critically the land levels downstream of the culvert need to be lowered by over 1.2m to allow return flow to the Otter and also to feed water more effectively into the Otter floodplain (figure 30).

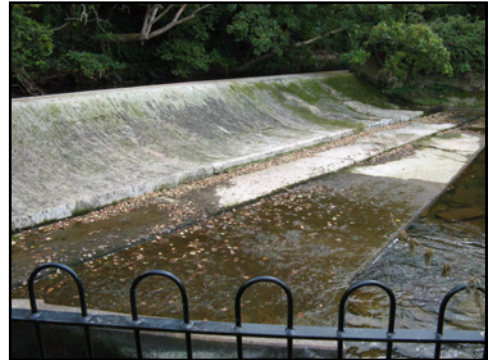
**Figure 31:** Image of Otterton Mill main weir, located upstream of the Mill. As viewed in October 2009.

It should be noted that currently the normal base flow is predominantly directed into the leat since the main weir was dry when viewed. The remaining flow passes down the fish pass, but also a major portion of flow passes under the weir and is visibly boiling up below the foundations of the structure. We would point out that is not in the best interests of this structure, composed of hydraulic lime concrete, to be dry and allowed to dry for prolonged periods. The weir leakage needs to be addressed, and also the flow through the leat and fish pass better adjusted to ensure that the weir is wet (figure 31).
